AIRPLANE SCATTER 1296Mhz

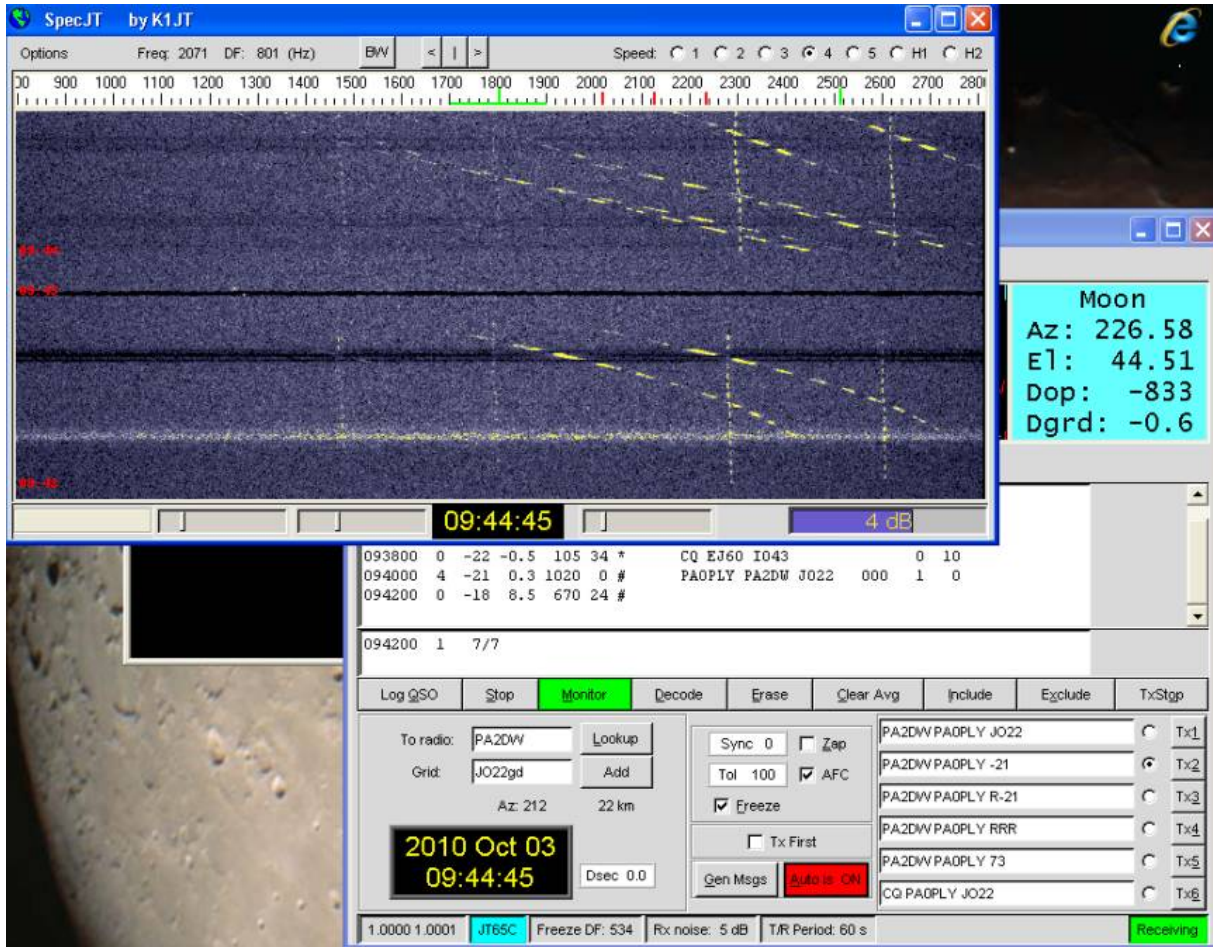
See below at 1500Hz the bounced EME signal of PA2DW sending RRR's in JT65 mode.

At 2300Hz the direct path and the swallow lines caused by airplane scatter.
